## Brian Burgess returns to tell you how to replace the anti-roll bar drop links and tie rods on your S-Type

# LINK REPL

# ACEMENT

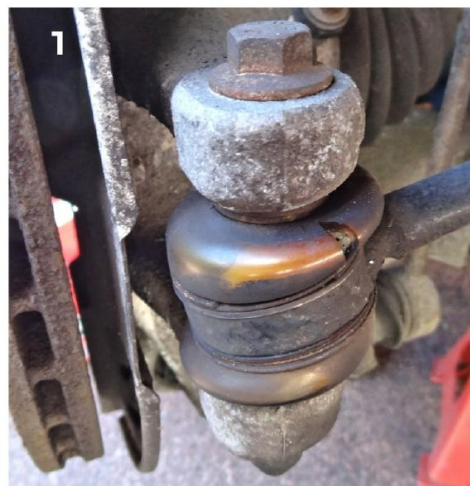
**1** Split dust cover – NS/rear stabiliser rod (outer rose joint)

Fortunately, I own a car lift and can carry out my own servicing as well as mechanical and electrical repairs. It was during a pre-MoT 'health check' on my S-Type that I spotted several split dust covers on a number of rear suspension link ball joints. In light of this, I thought that I would share with you the process of replacing four critical rear suspension components – the left and right rear sway (anti-roll) bar drop links and the left and right rear stabilising links, also known as tie rods. The work was carried out on a 2005 model-year S-Type – from VIN M79146 (diagram 4) – but other years/models will be similar. These components were replaced because the ball-joint dust covers were showing signs of deterioration and splitting.

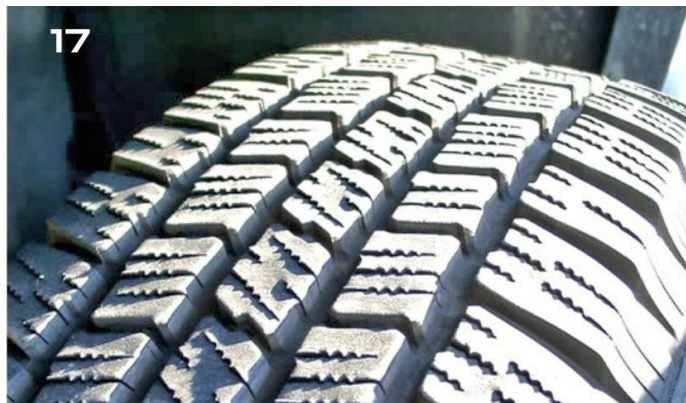
If you suspect that the rear wheels are out of alignment, look for signs of uneven tyre wear. A good example of this is 'blocking',

where the tread blocks appear to have been dragged diagonally across the width of the tyre causing a raised lip on each block (17). Jaguar Cars refers to the condition as 'crabbing', where the vehicle is travelling forwards and a little sideways at the same time.

**12** New O/S-rear tie rod and drop link secured **13** N/S-rear tie rod adjuster locked and treated with copper grease **14** Sub-frame fixing point for tie rod **15** Anti-abrasion rubber block between upper drop link fixing and park brake cable **16** Aftermarket ball joint dust covers and retaining coil clips **17** Example of 'tread blocking' symptomatic of rear wheel alignment error
